First Floor Slab Evaluation

Northfield Fire Station

93 Main Street

September 16, 2019

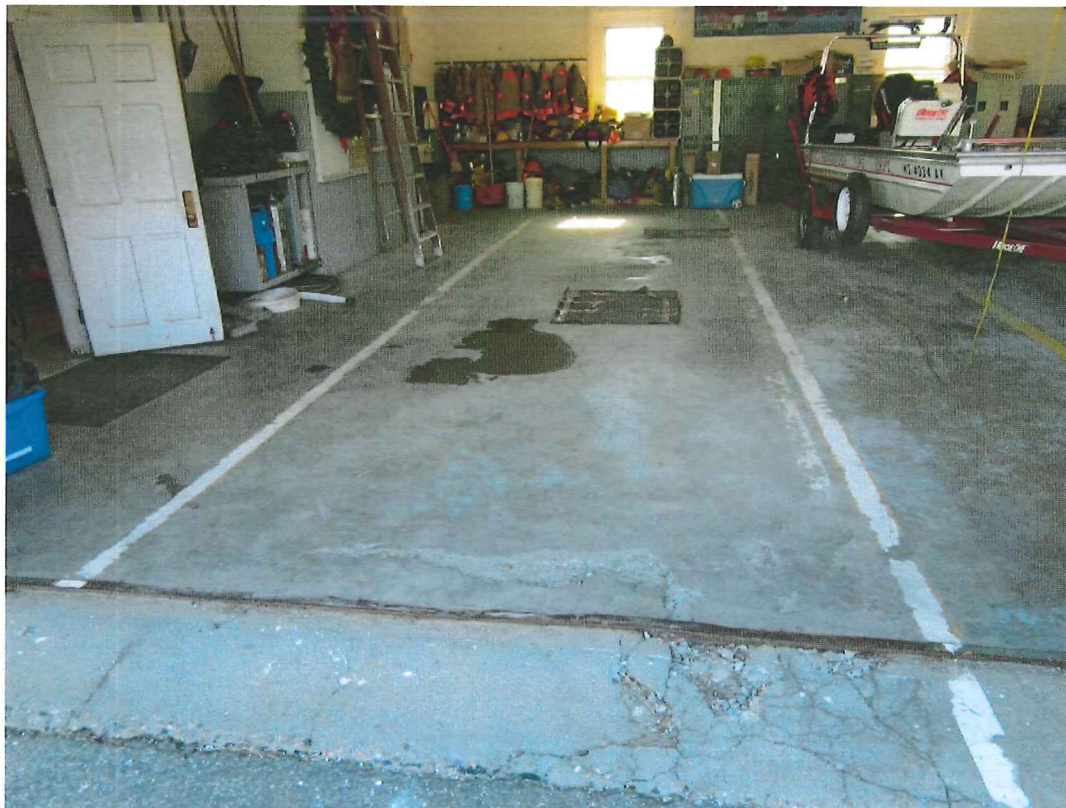
In the three parking bays, there was evidence of some surface cracking and spalling at the door openings and at several places in the field (photos 1 - 9.) The spalls at the door openings were due to water absorption. At other locations, the spalls may be due to standing water absorbed at low points, road salt, impact from dropped equipment, or overloading. The capacity of the slab was not impacted by the top surface spalls.

1. First Floor, Bay 1 slab. Spalls at apron and front of slab.

1. Patch the top of the first floor slab where damaged with Silpro Feather Spread RPS concrete repair mortar.
2. Seal the slab to prevent further water infiltration (Silpro Silocks Plus, SuperSeal25.)

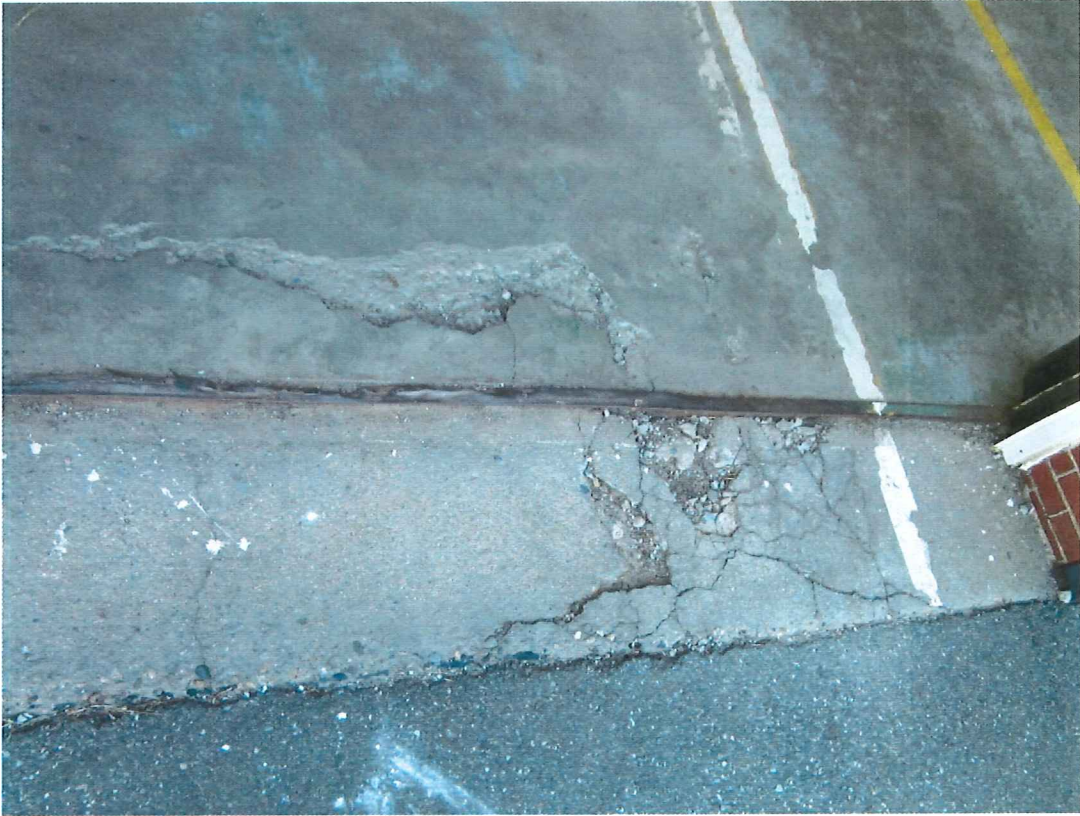
2. First Floor, Bay 1 slab. Enlarged spalls at apron and front of slab.

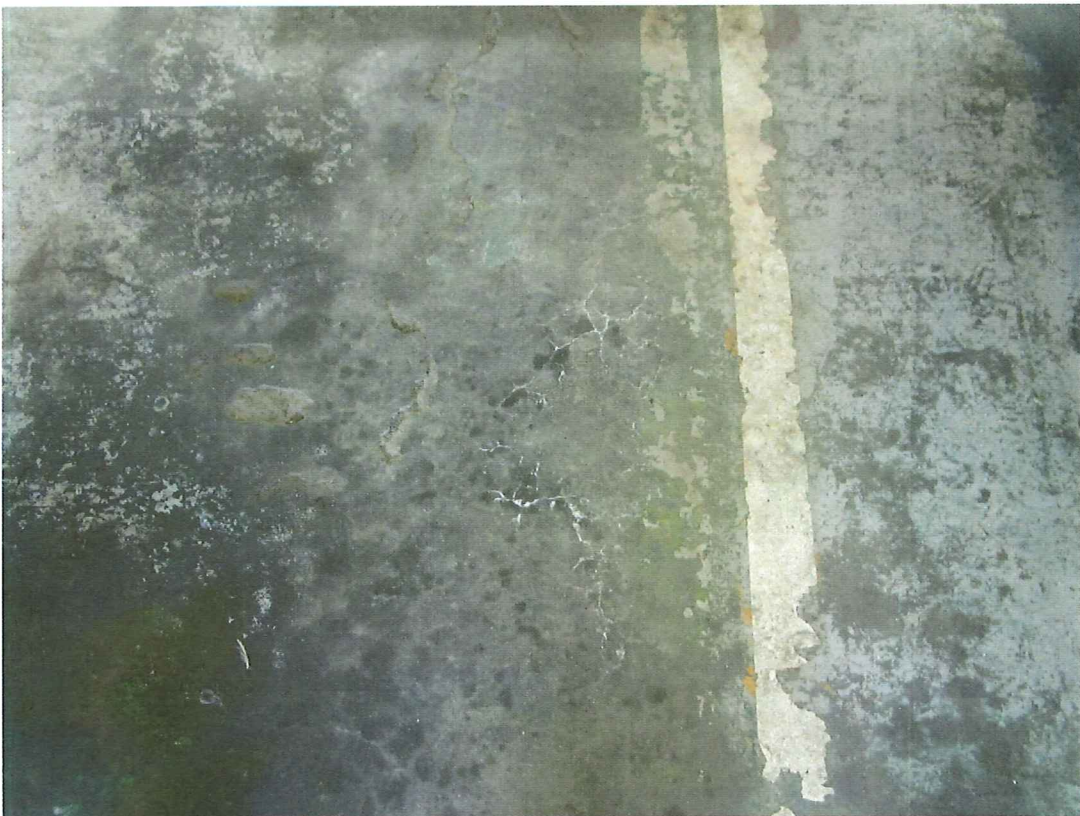
3. First Floor, Bay 1 slab. Surface spalls.

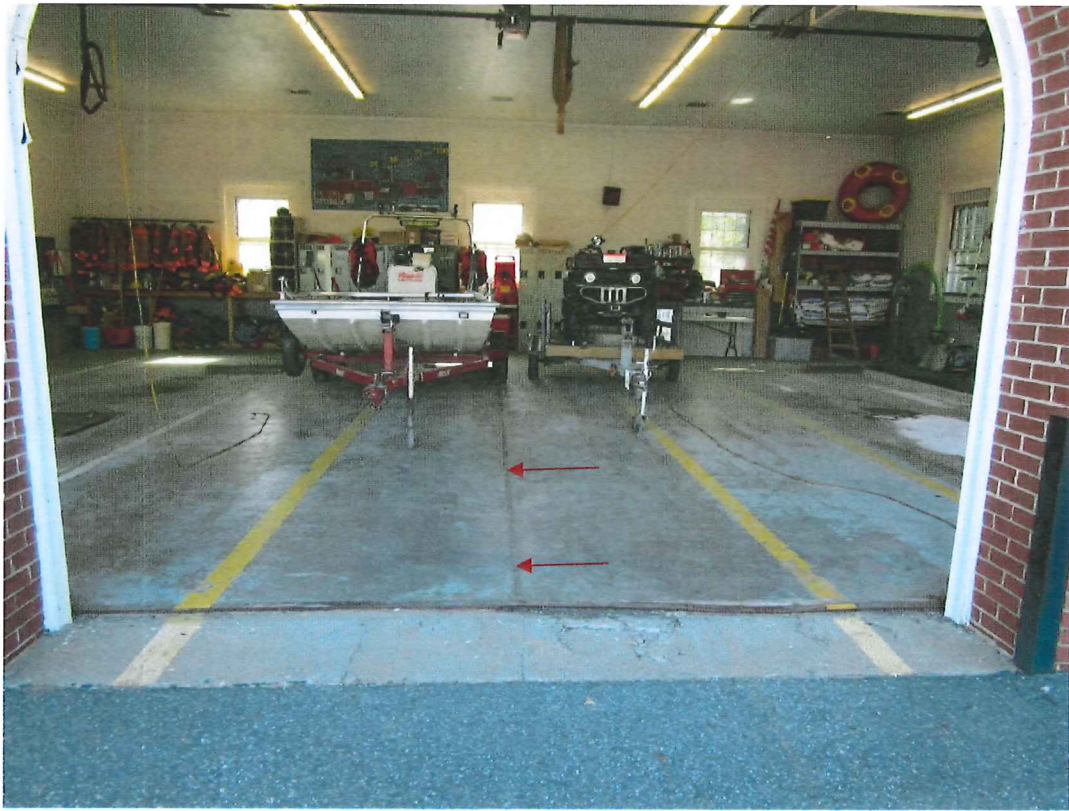
In the middle bay, Panels 3 and 6 were modified when the expansion joint was cut into the center of the panels (photos 4, 7.) Those two panels were analyzed with the slab depth reduced to 5 in. The result was that, as modified, the slab capacity was somewhat reduced, yet still capable of supporting the 24,000 axle load. However, the cracking and spalling of the concrete and the exposed rebar on the underside of the slab (due to water infiltration) are evidence that the slab is no longer intact and is incapable of supporting the design load (see Recommendations for Slab Loading, below.) The current safe loading capacity is unknown.

In the center bay, the expansion joint caulking was observed to be dried and shrunken, and no longer effective at preventing water from entering the slab (photos 4, 7.) In the basement, there was cracking and spalling of the underside of the slab and six exposed rebar directly under the expansion joint (photos 10 - 14.)

4. First Floor, Bay 2 slab. Surface spalls at apron and front of slab. Expansion joint.

7. Remove the caulk from the expansion joint and re-seal with elastomeric joint filler.
8. Re-point the chimney where needed and replace any spalled bricks.

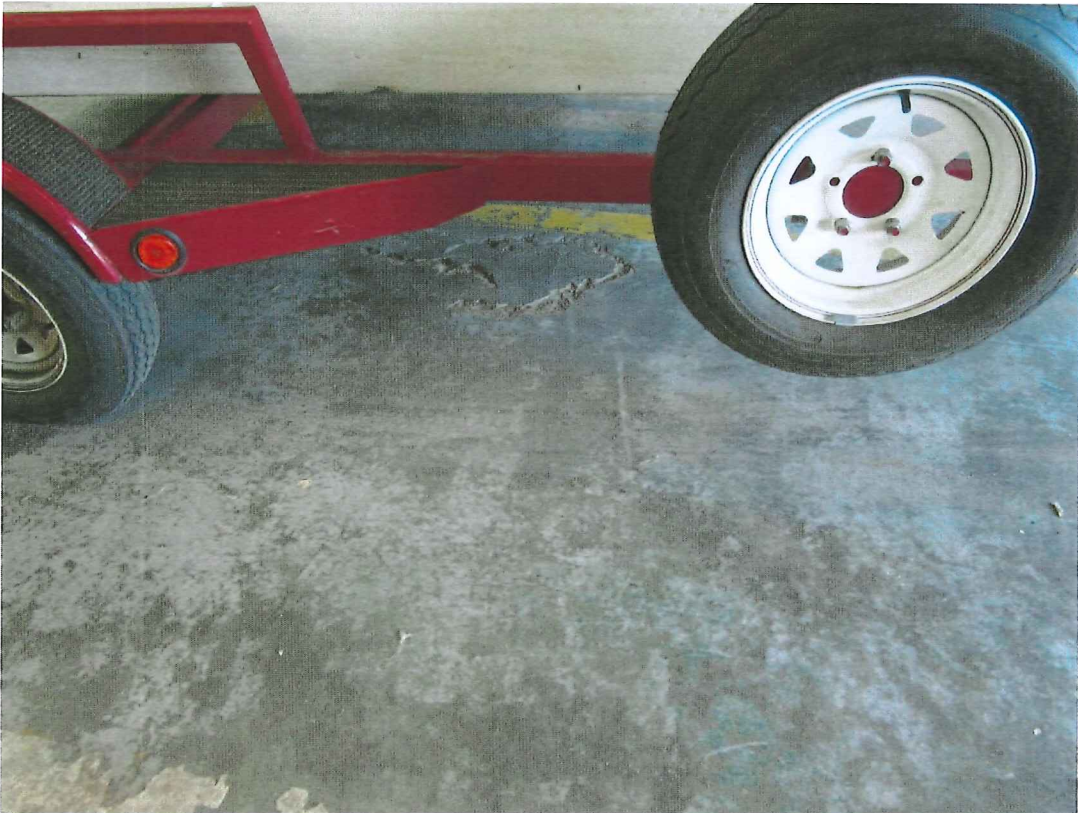
5. First Floor, bay 2 Slab. Surface spalls.

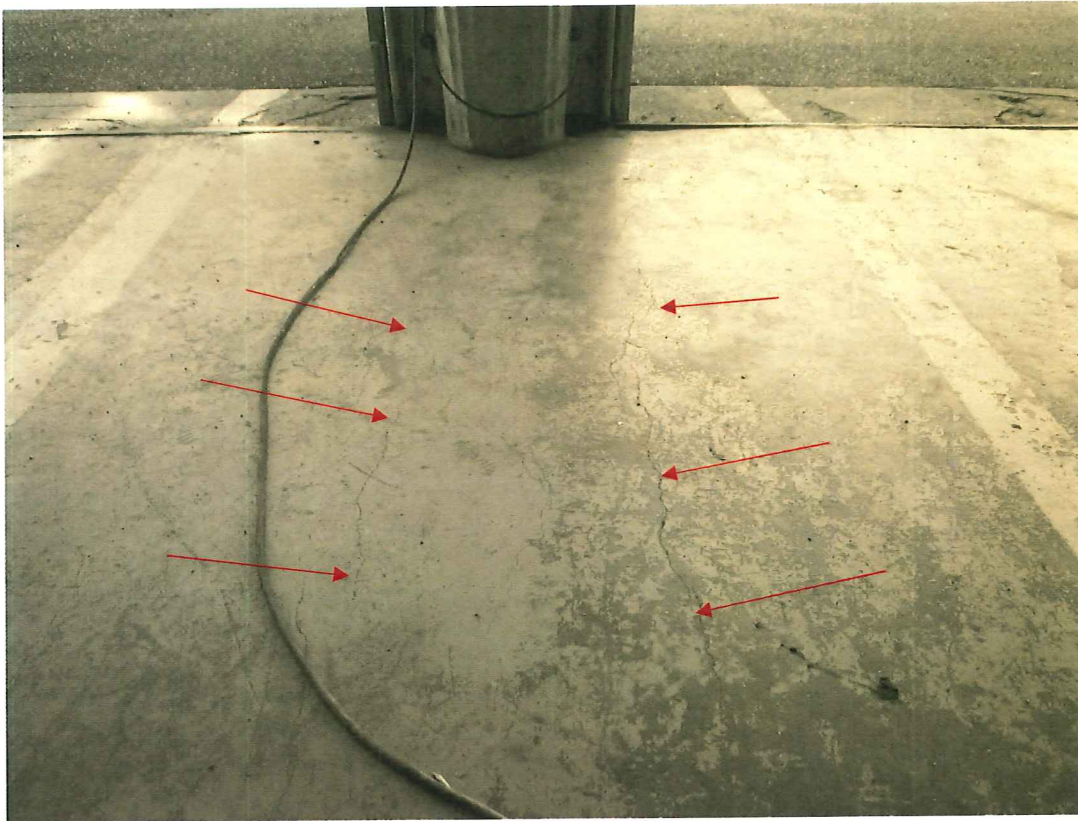
6. First Floor, between bay 2 and bay 3. The parallel cracks are right over the edges of the support beam below indicating that the slab has been overstressed.

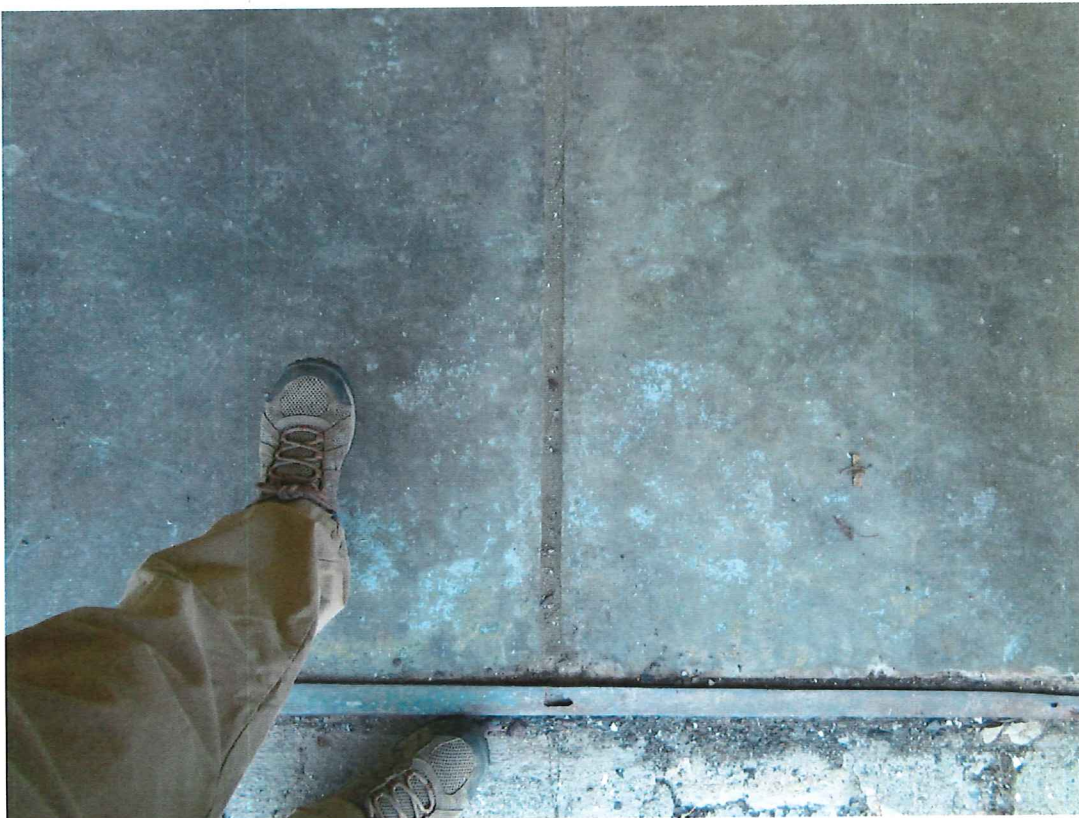
The slab was supported by interior beams running both north/south, and east/west. The top of the slab is cracked above both of the east/west running beams (between bays 1 and 2, 2 and 3) (photo 7.) The width of the cracks varied from 0.007 in. to 0.04 in., exceeding the maximum of 0.0014 in. These cracks are a concern. They indicate that the slab has been loaded beyond its capacity.

7. Bay 2 Slab. Expansion joint. Caulking is dried out and shrunken.

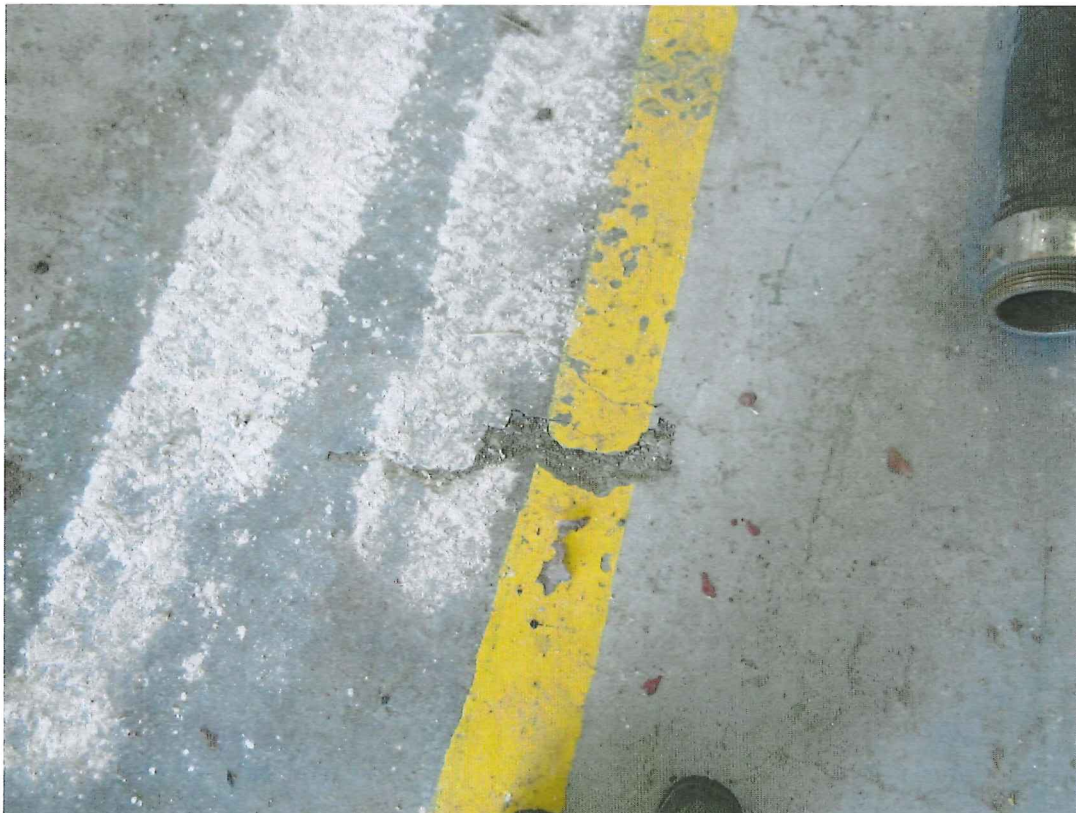
9. Bay 3 Slab. Surface spalls.

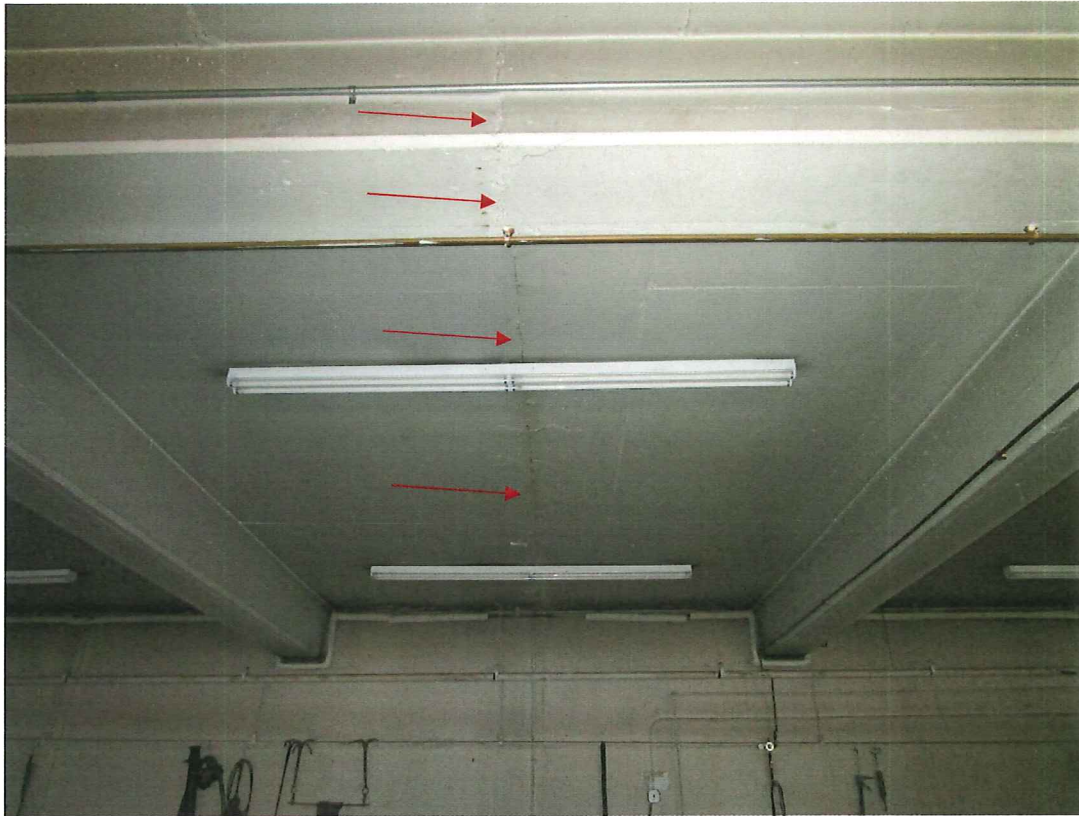
The one exception is beam #5, spanning north/south under the middle bay (photos 10 - 14.) It was assumed that this beam was compromised by the leak at the expansion joint. It is cracked in the middle (0.016".) It is no longer capable of safely supporting the design load. Its current safe loading capacity cannot be determined by calculation.

10. Bay 2 Slab, underside, Panel #6. Cracks in slab and beam.

3. Repair the underside of the floor slab. Remove loose concrete. All rusted rebar will need to be exposed on all sides and cleaned to bare metal. Concrete edges will have to be saw-cut with an undercut and deteriorated concrete will have to be removed. Patch with Silpro's SilproRepair™ VOH.

4. Repair the concrete beams over the lower level overhead doors using Silpro's SilproRepair™ VOH.
5. Repair Beam #5 using Silpro's SilproRepair™ VOH.
6. Where cracked, repair the concrete block walls in the basement and first floor levels with Quikwall Surface Bonding Cement (manufactured by Quikrete) or similar product.

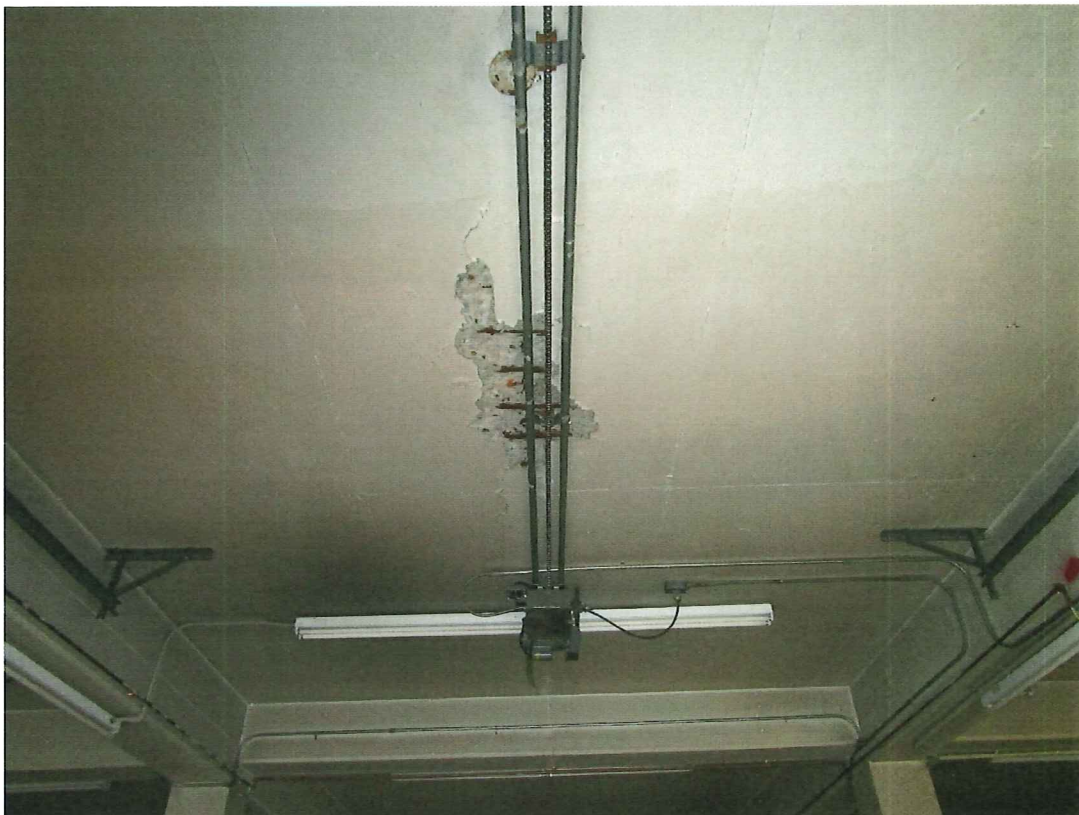
In areas where pieces of the concrete have spalled off and the rebar is exposed and rusted, water absorption was the cause. Water in the concrete causes the rebar to rust. When steel rusts, it expands up to 7 times the original steel thickness with a pressure of up to 9,000 psi. which exceeds the tensile capacity of the concrete, therefore, the concrete breaks. The exposed steel still has some capacity to support loads, but the lack of concrete cover over the rebar and the reduction in the cross section of the rebar disallow the use of the methods used to calculate the strength of a concrete member. Therefore, the capacity is unknown.

11. Basement, bottom of first floor slab, center bay, Panel #3. Spalled concrete and rusted rebar.

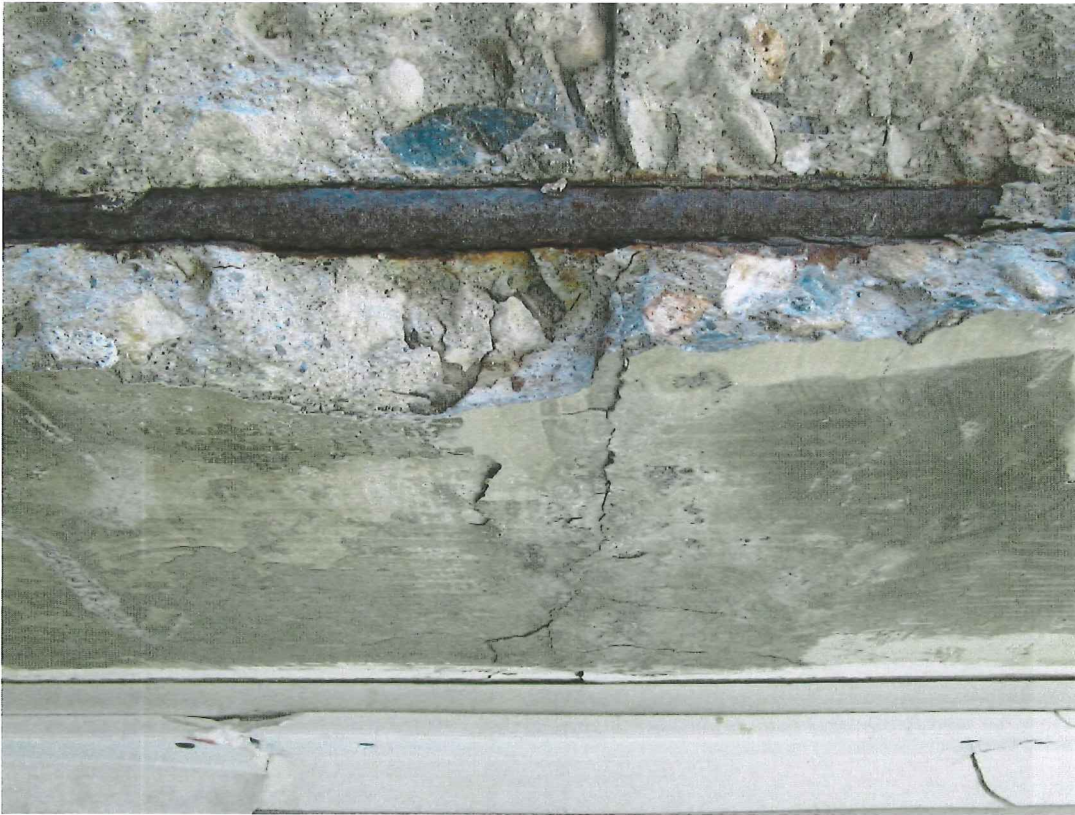
12. Basement, bottom of first floor slab. Close-up of rebar.

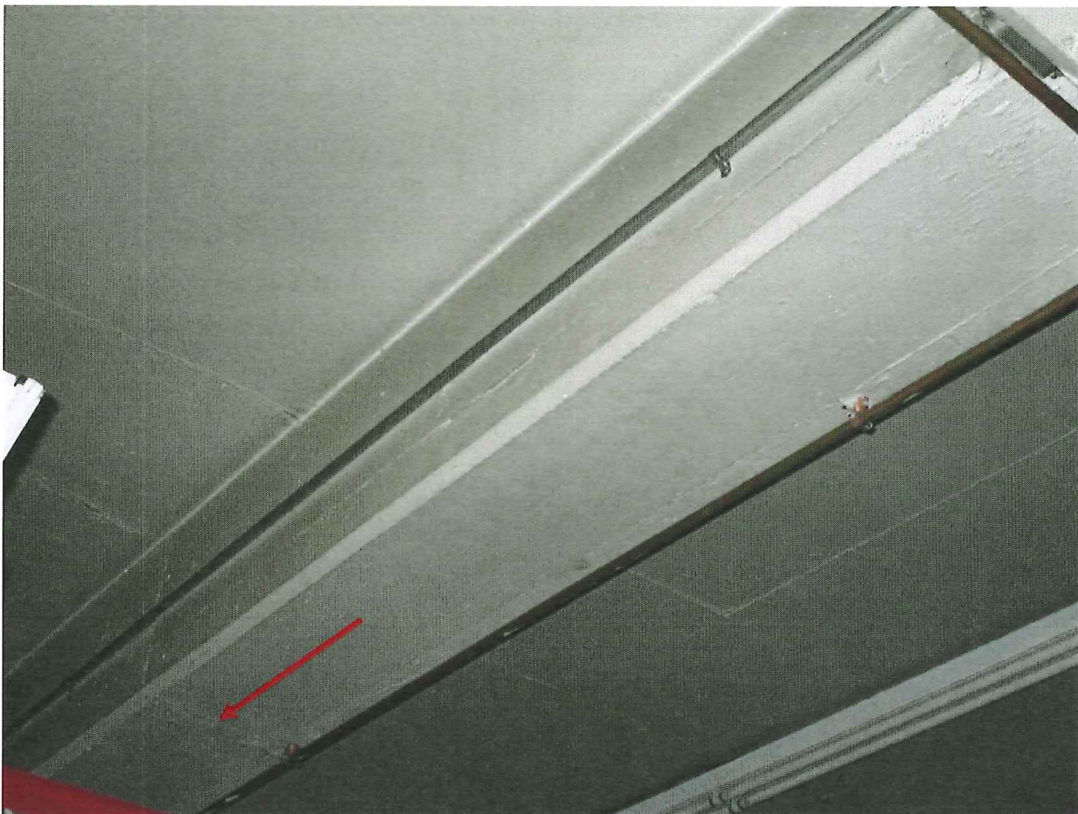
13. Basement ceiling. Cross beam, middle bay, cracked.

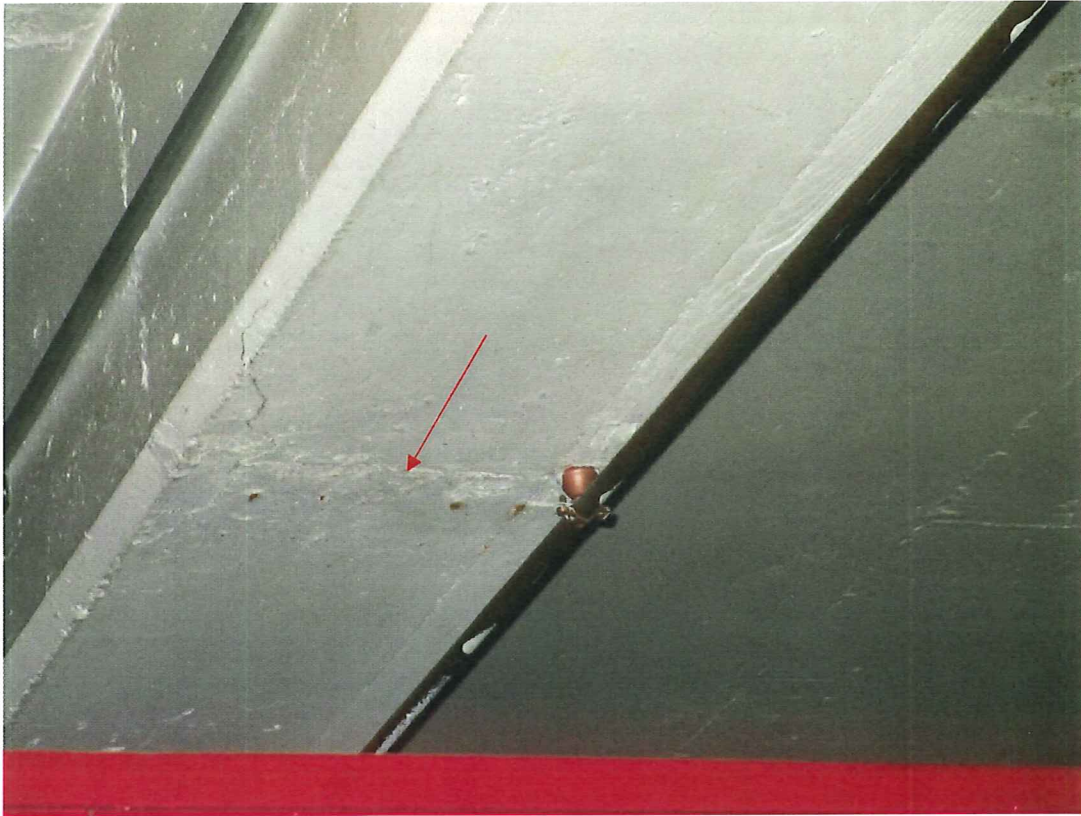
14. Basement, ceiling. Cross beam. Crack.

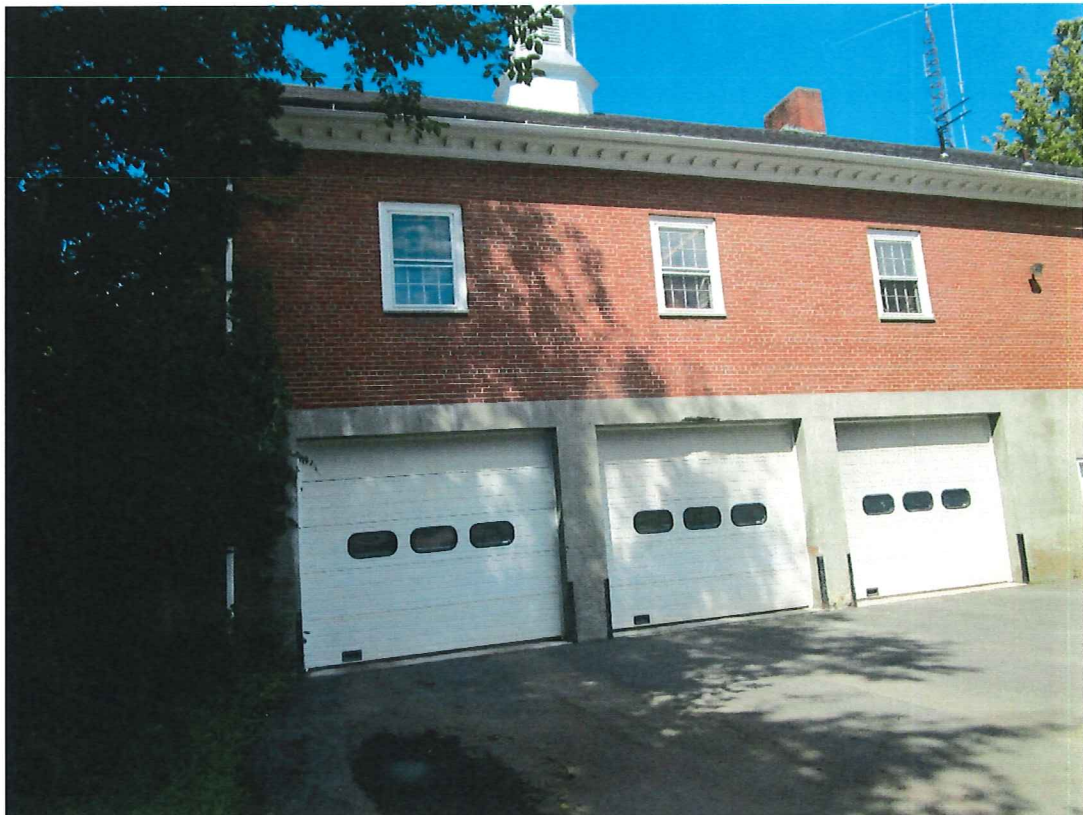
The concrete beams over the lower level overhead doors (Beams 1, 2, and 3) did exhibit excessive cracking and spalling (photos 14 - 18.) An analysis of these beams was performed which indicated that the lintels were designed to support the wall and roof above and the load from the slab relative to the 12,000 lbs. axle load. However, the degree of cracking in all three beams indicates that the beams have been overstressed. Because of their exposure to weather and the spalled concrete in the middle beam, it was assumed that rusted rebar was the cause of the cracks. Again, the current capacity is something less than the design load.

The three concrete beams that span across the overhead door openings exhibit vertical cracks on the outside face as well as horizontal cracks on the underside (photos 15 - 21.) The center bay exhibits spalling of the concrete and exposed rebar. The cracks are consistent with beams that have exceeded the design capacity. Expansion of water entering the cracks exposed to freeze/thaw cycles has likely increased the width and depth of the cracks. The analysis indicated that the three beams should have been able to support the axle loads from the slab.

15. East side, Concrete lintel above overhead door openings.

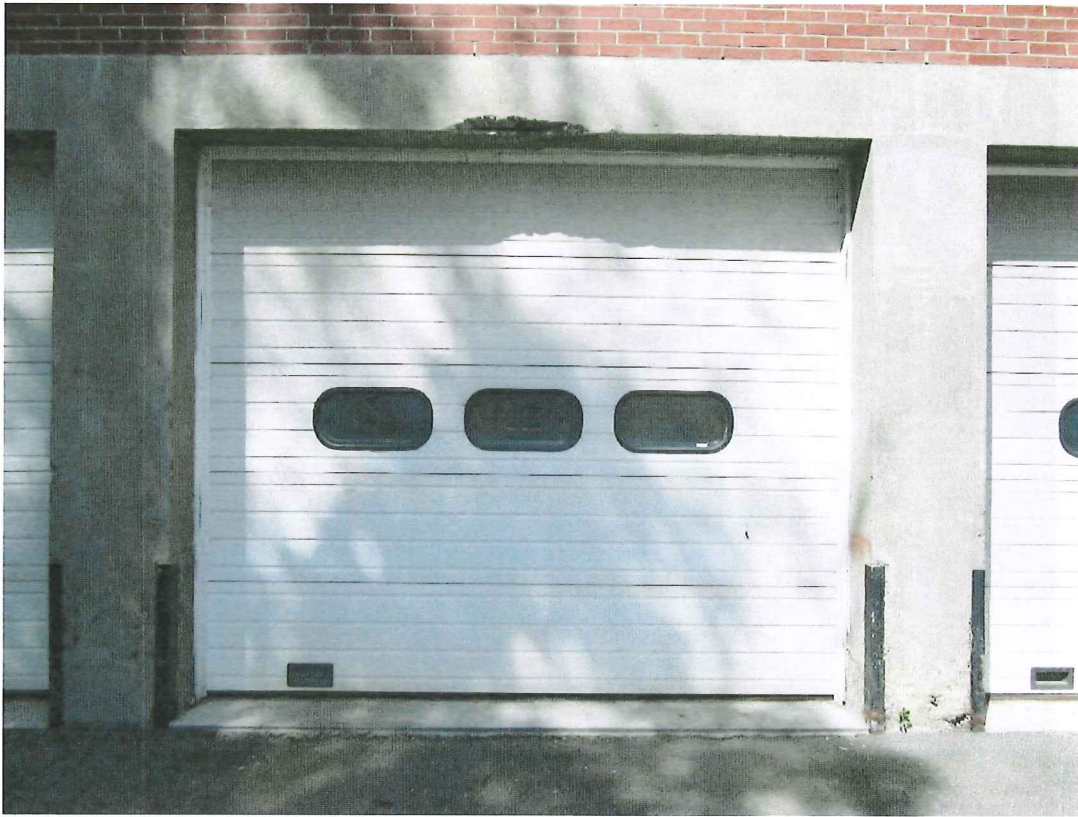
16. East side, concrete lintel, middle bay.

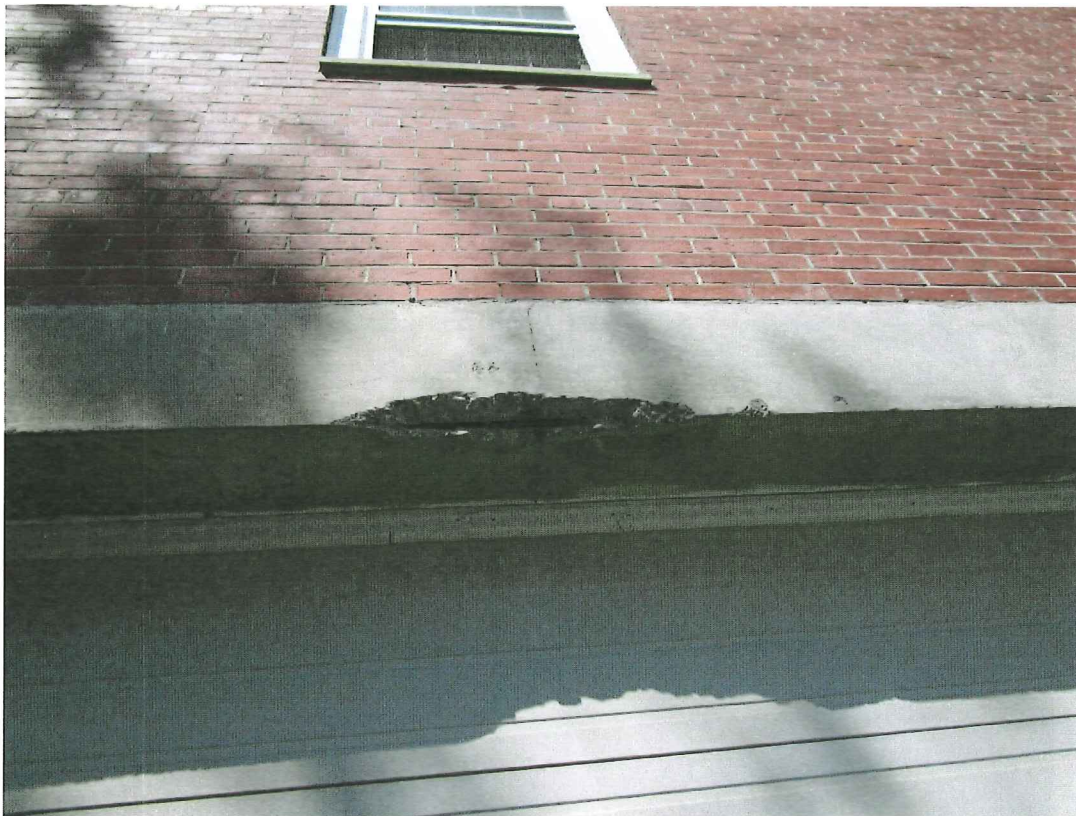
17. East side, concrete lintel, close-up.

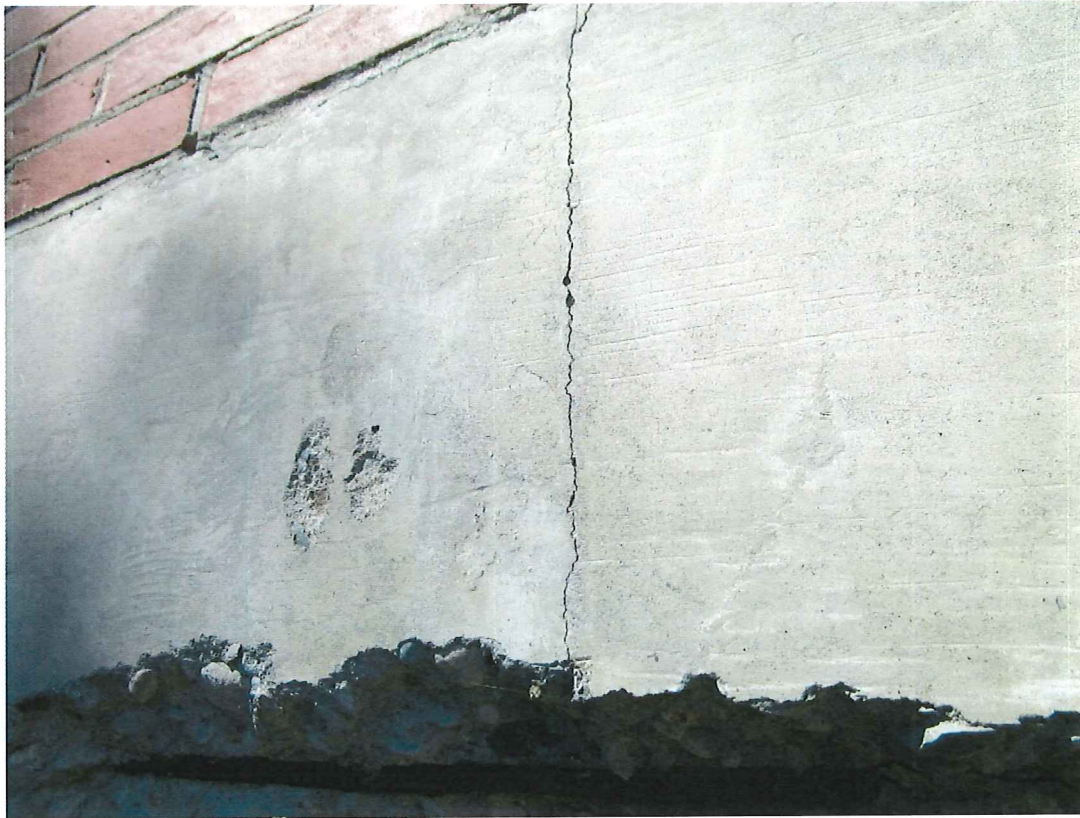
18. East side, concrete lintel, close-up, vertical crack.

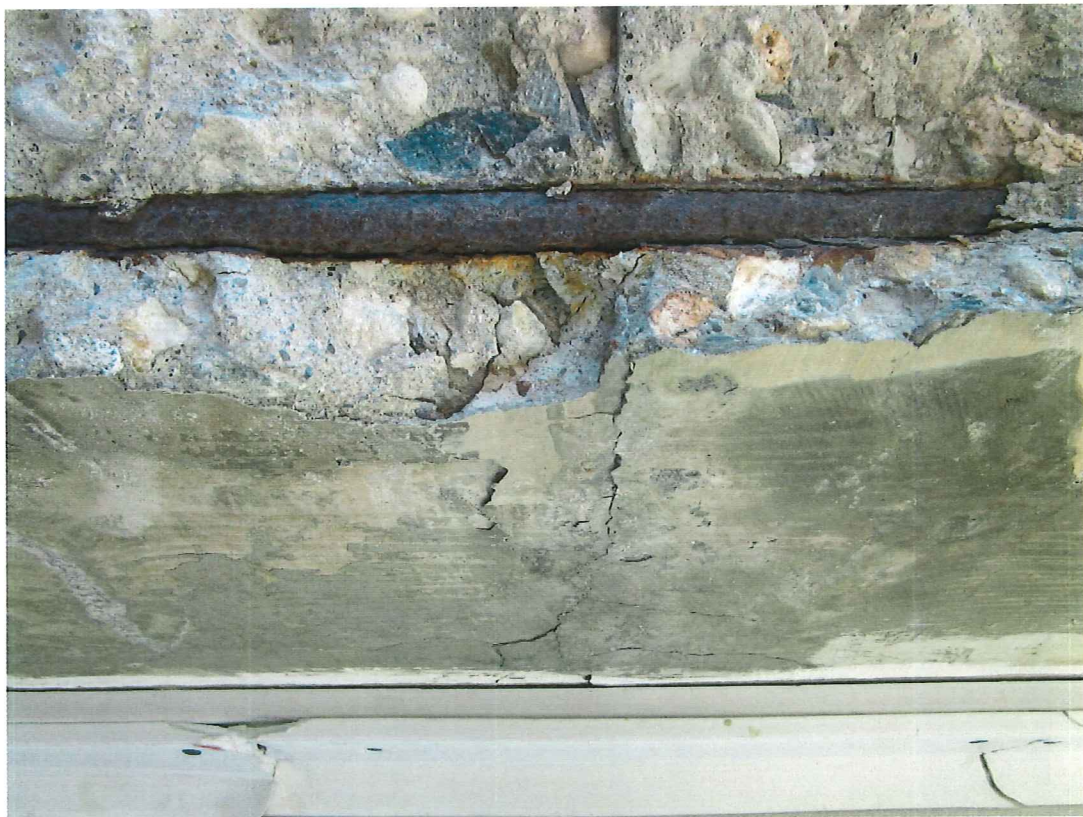
19. East side, concrete lintel, close-up bottom side crack, exposed rebar.

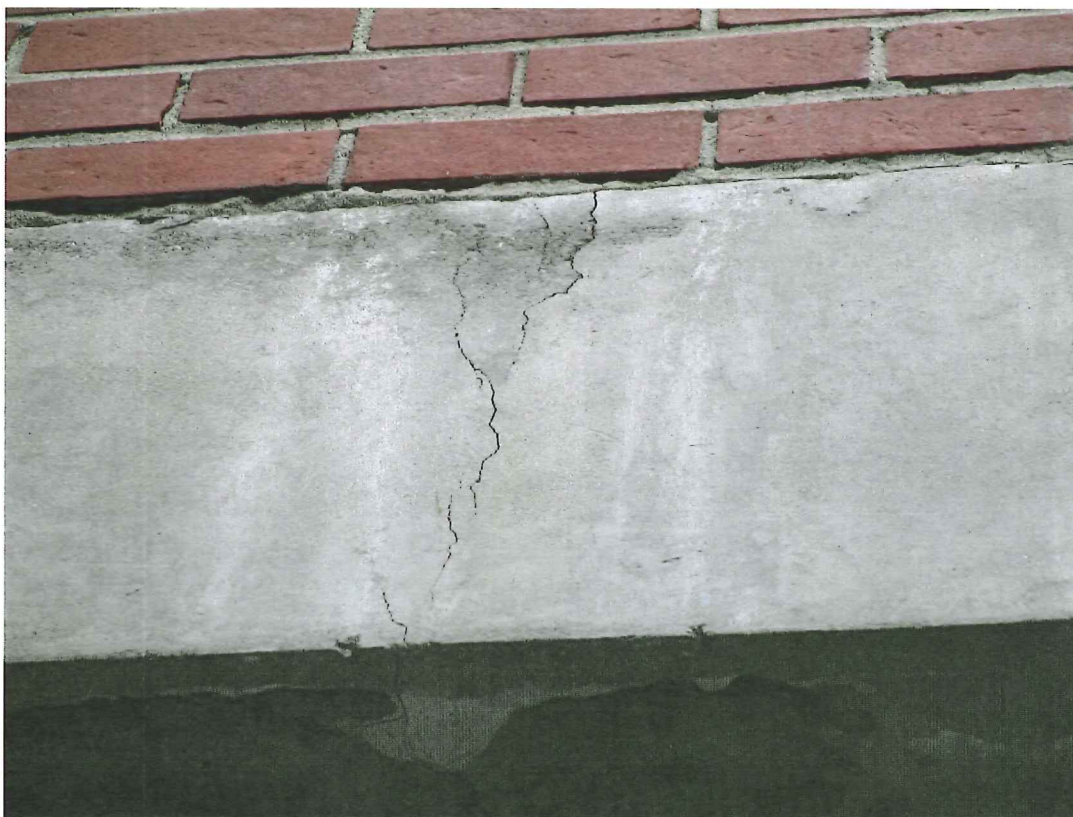
20. Beam #3. Cracked.

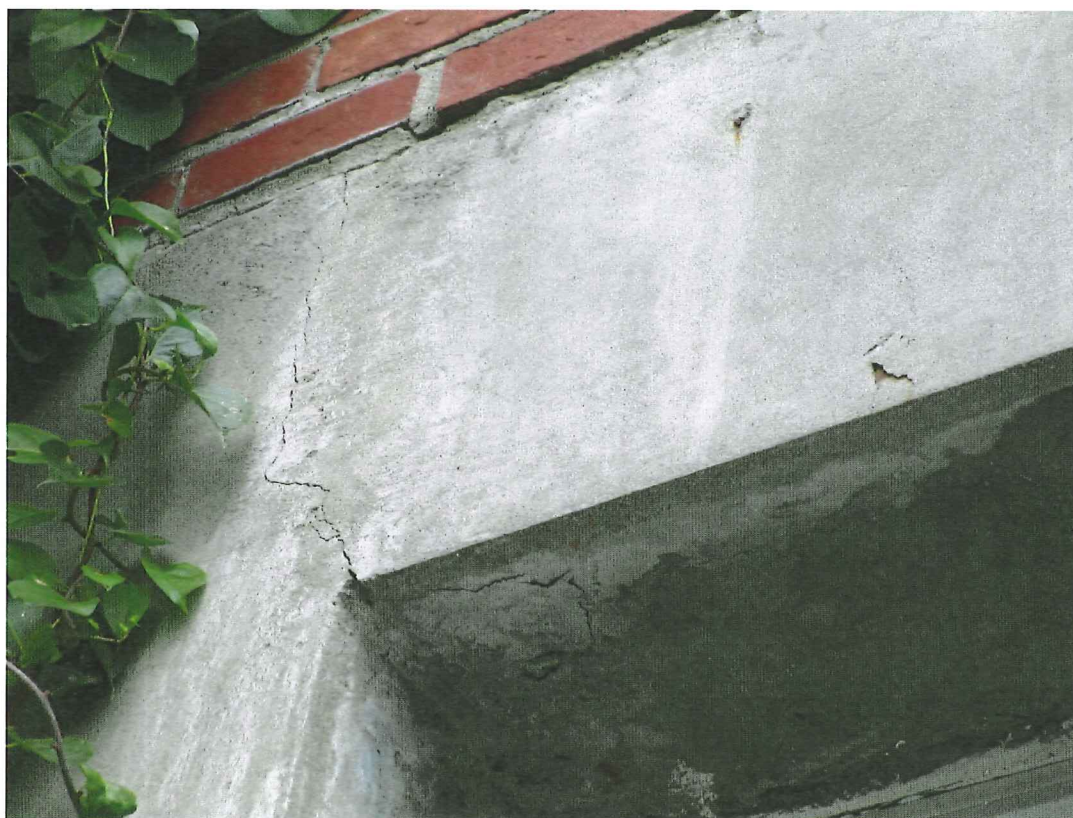
21. Beam #3. Cracked.

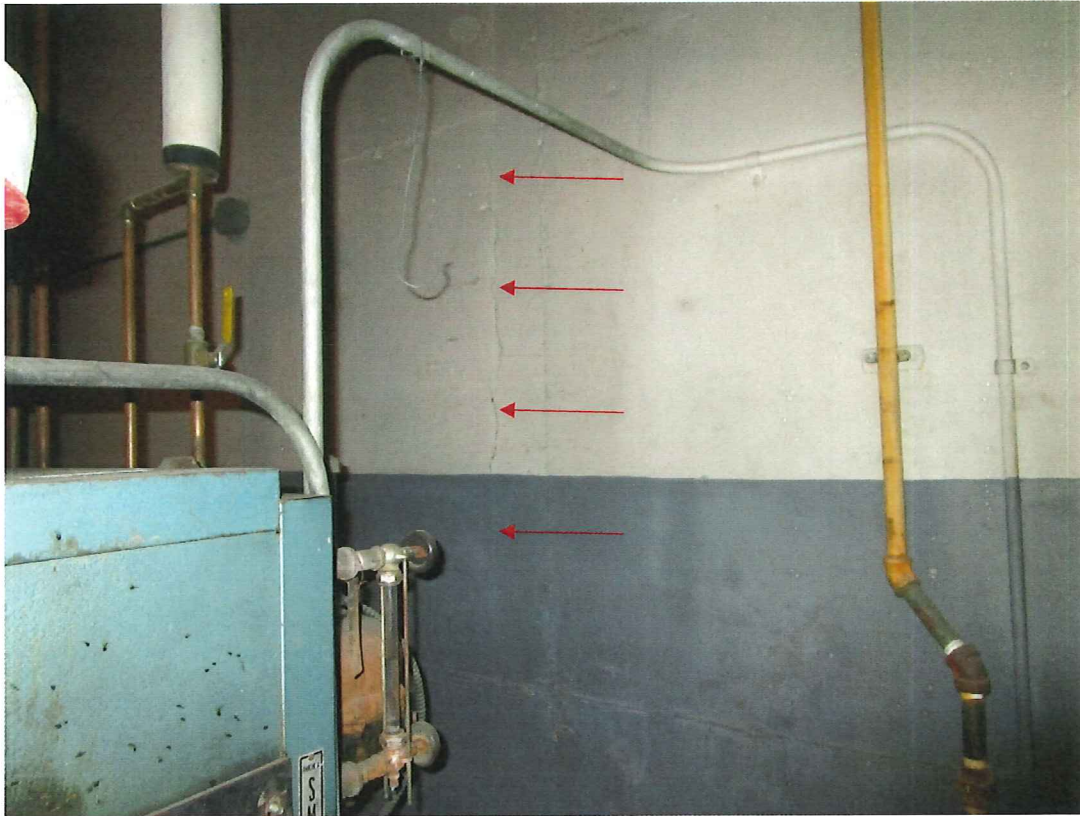
The concrete block wall between the boiler room and the adjacent parking bay exhibits a vertical crack along the mortar joint running from floor to ceiling (photos 22, 23). The crack is most likely caused by settlement of the soil beneath the footings. It is not a danger, but it should be repaired as recommended below.

22. Basement, concrete block wall between boiler room and garage cracked.

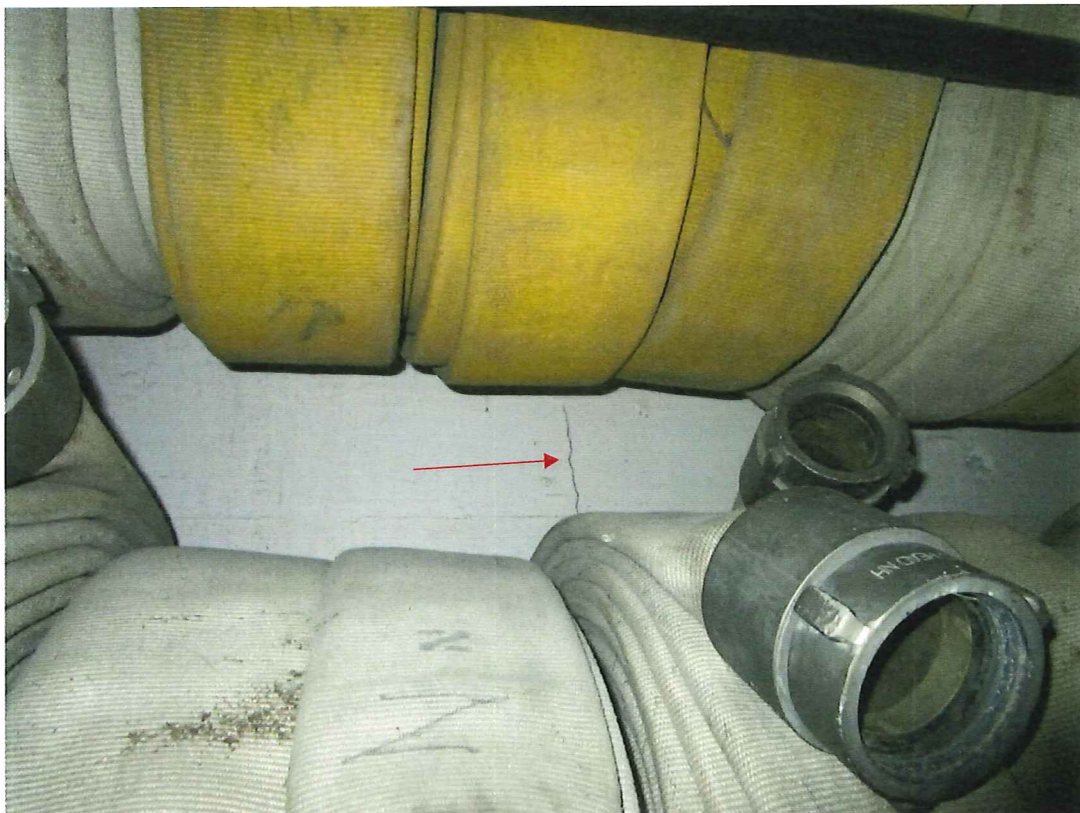
23. Basement, concrete block wall crack, garage side.

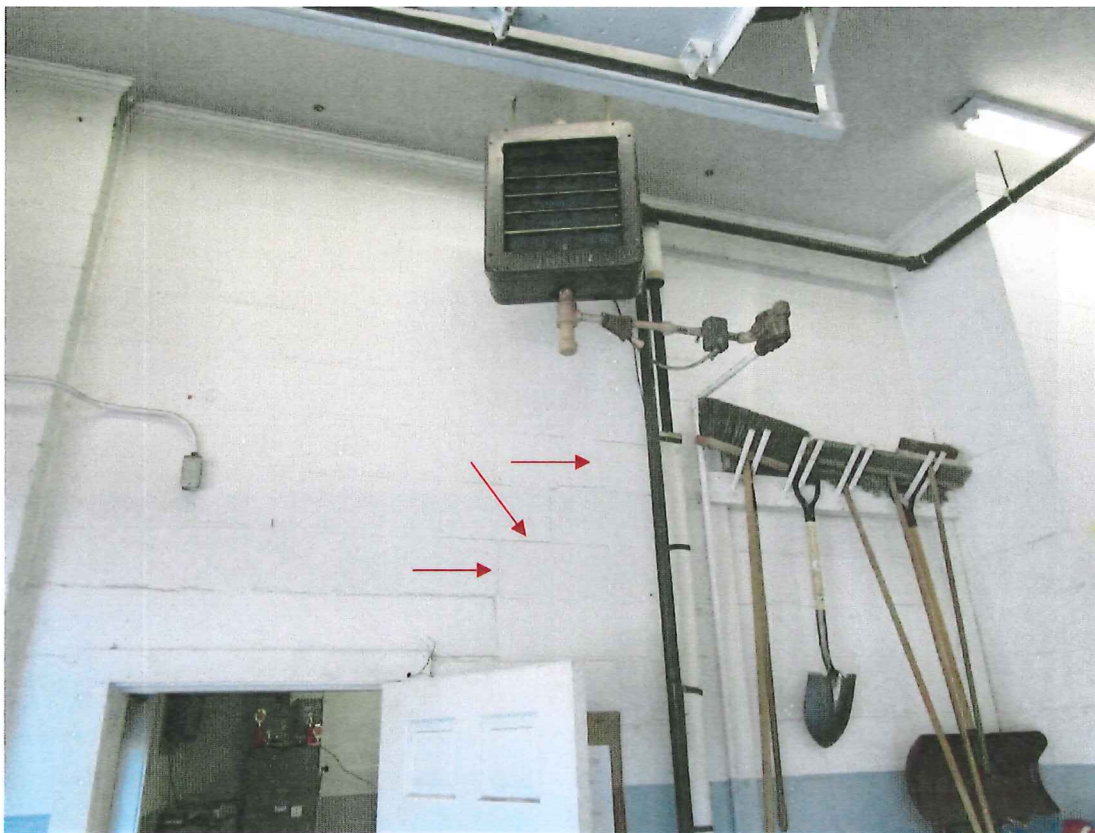
The concrete block walls on the north, east, and south sides of the parking area are all exhibiting cracking of the mortar joints (photos 24 - 28.) On the north and south sides, the cracking is most likely due to settlement of the foundation. They do not present a danger, but they should be repaired as recommended below.

24. First floor, concrete block wall between office and garage. Cracked mortar joints.
