First Floor Slab Evaluation

Northfield Fire Station

93 Main Street

September 16, 2019

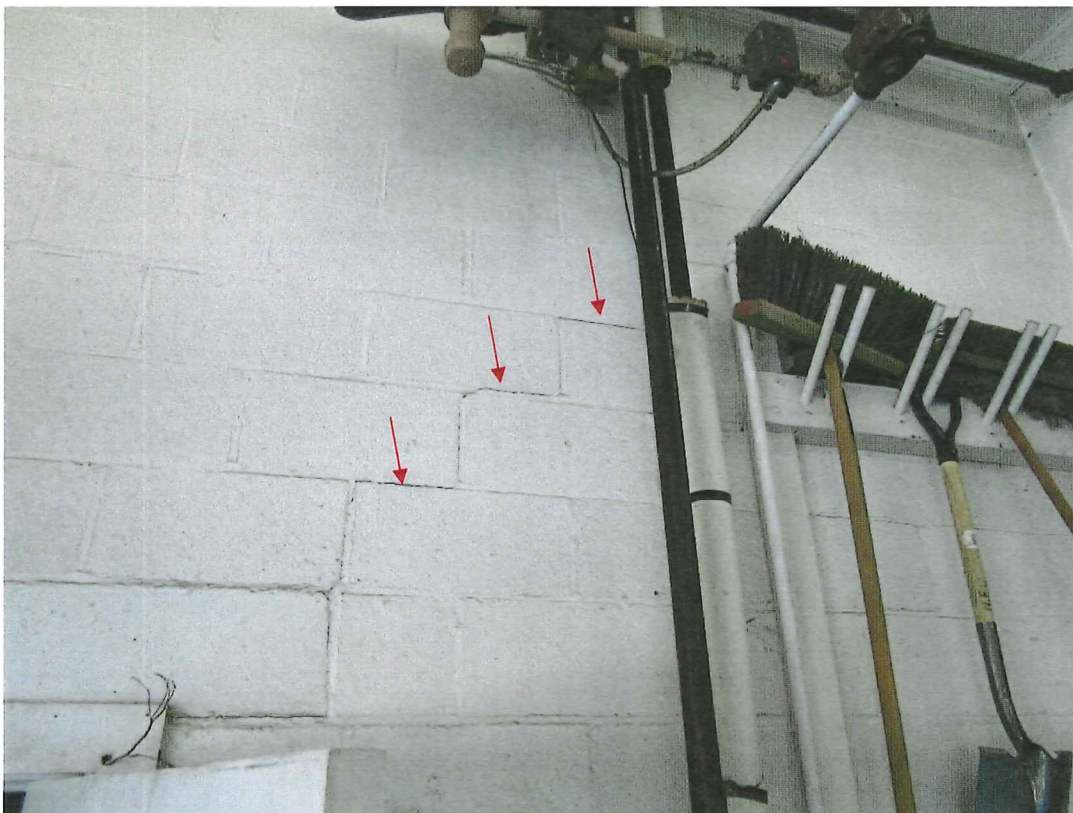
The concrete block walls on the north, east, and south sides of the parking area are all exhibiting cracking of the mortar joints (photos 24 - 28.) On the north and south sides, the cracking is most likely due to settlement of the foundation. They do not present a danger, but they should be repaired as recommended below.

25. First floor, concrete block wall between office and garage. Close-up, cracked joints.

4. Repair the concrete beams over the lower level overhead doors using Silpro's SilproRepair™ VOH.
5. Repair Beam #5 using Silpro's SilproRepair™ VOH.
6. Where cracked, repair the concrete block walls in the basement and first floor levels with Quikwall Surface Bonding Cement (manufactured by Quikrete) or similar product.

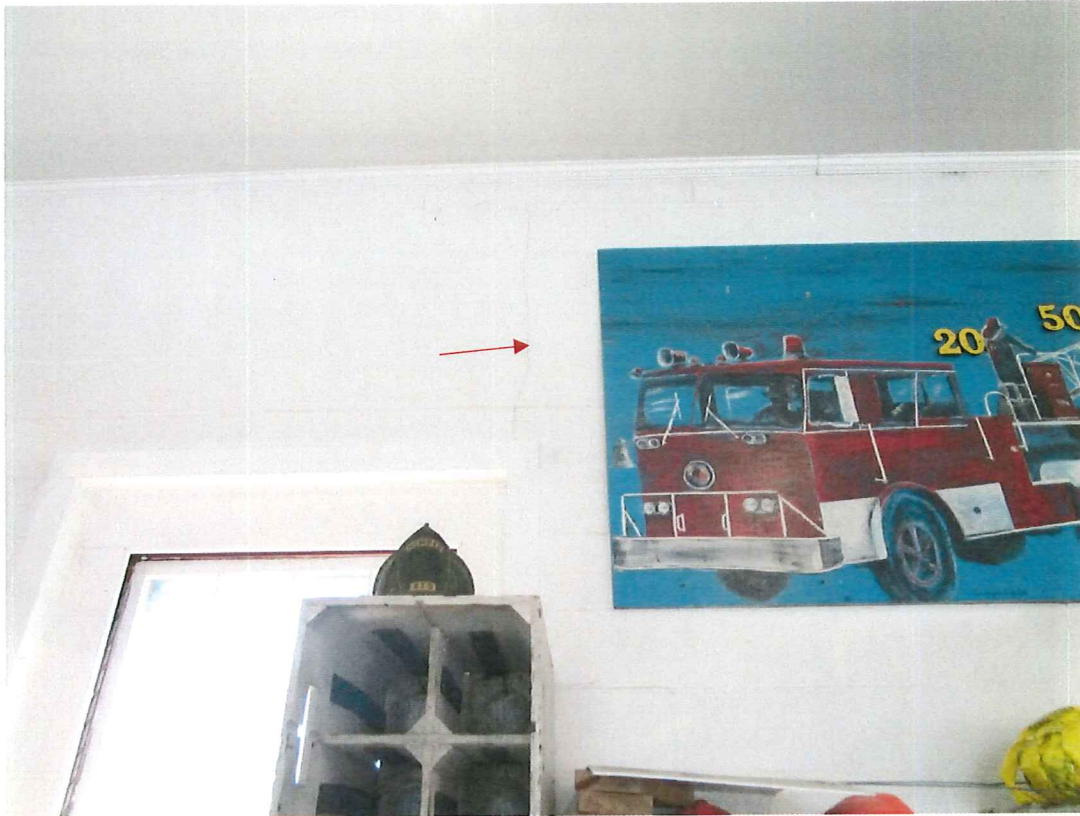
On the east side, the cracks are more extensive. They are due to the stress in the wall resulting from the overstressed beams below at the overhead doors.

26. First floor, back wall. Block wall cracked.

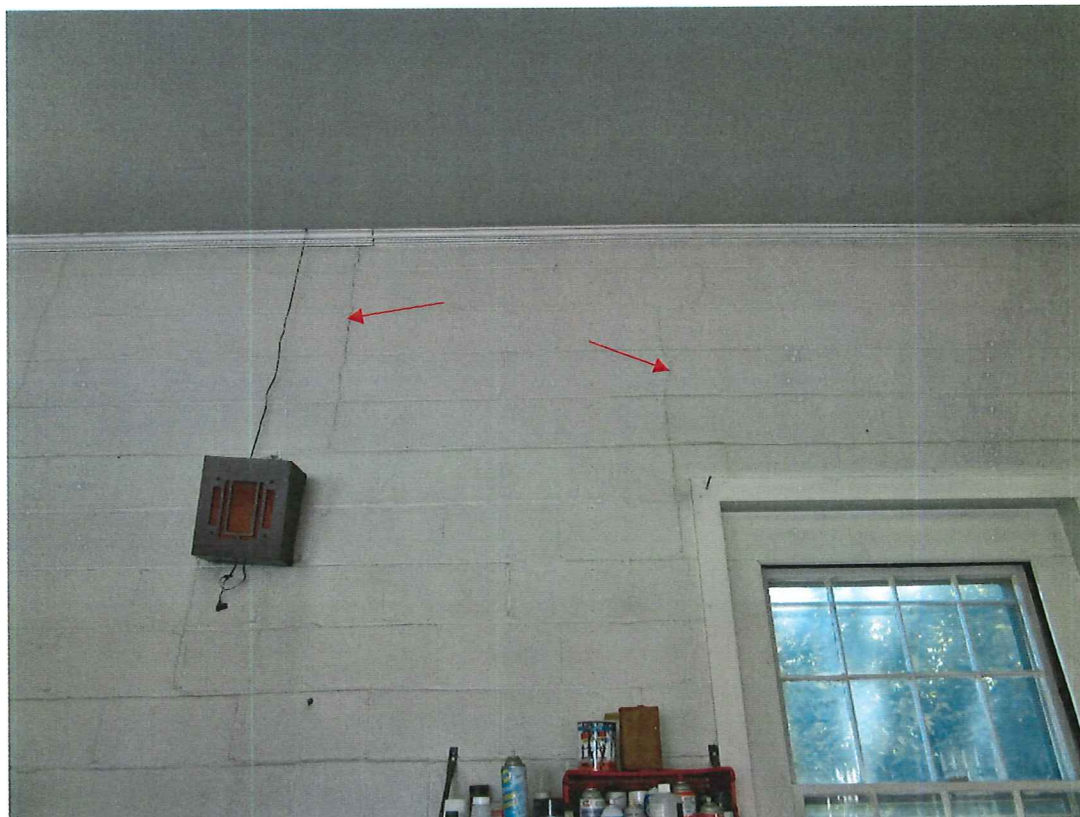
27. First floor, back wall. Block wall cracked.

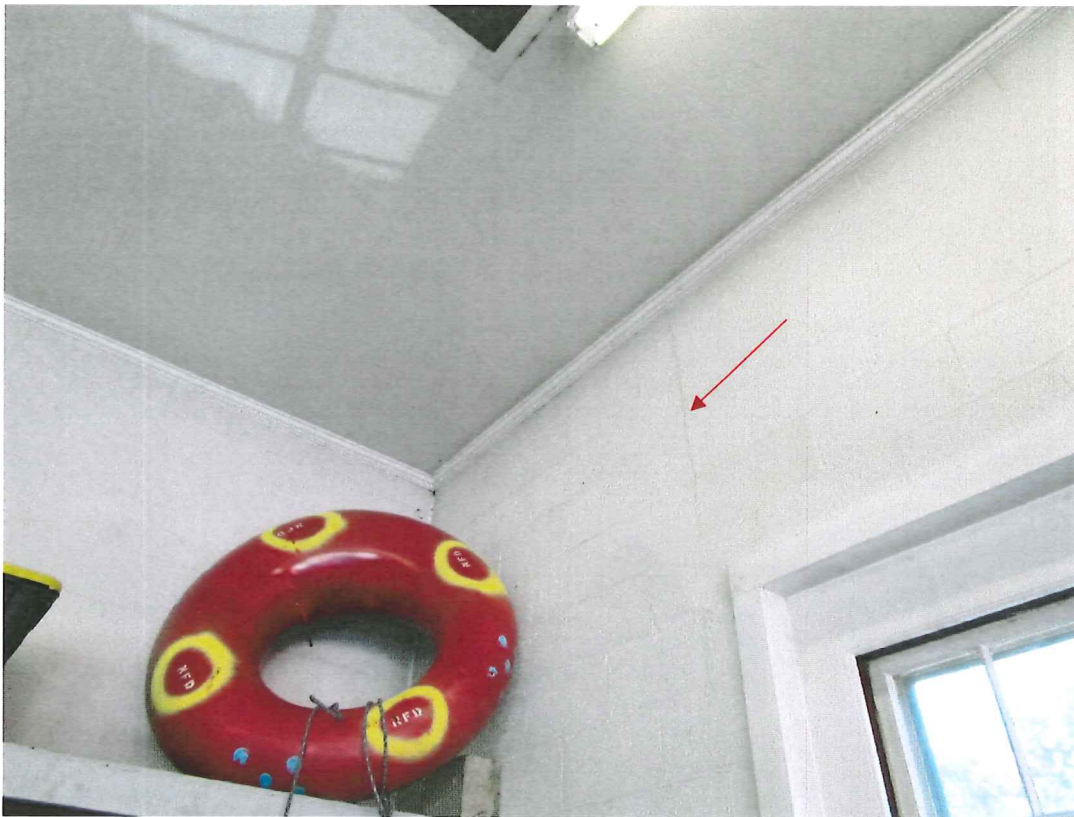
28. First floor, south wall, southeast corner. Block wall cracked.

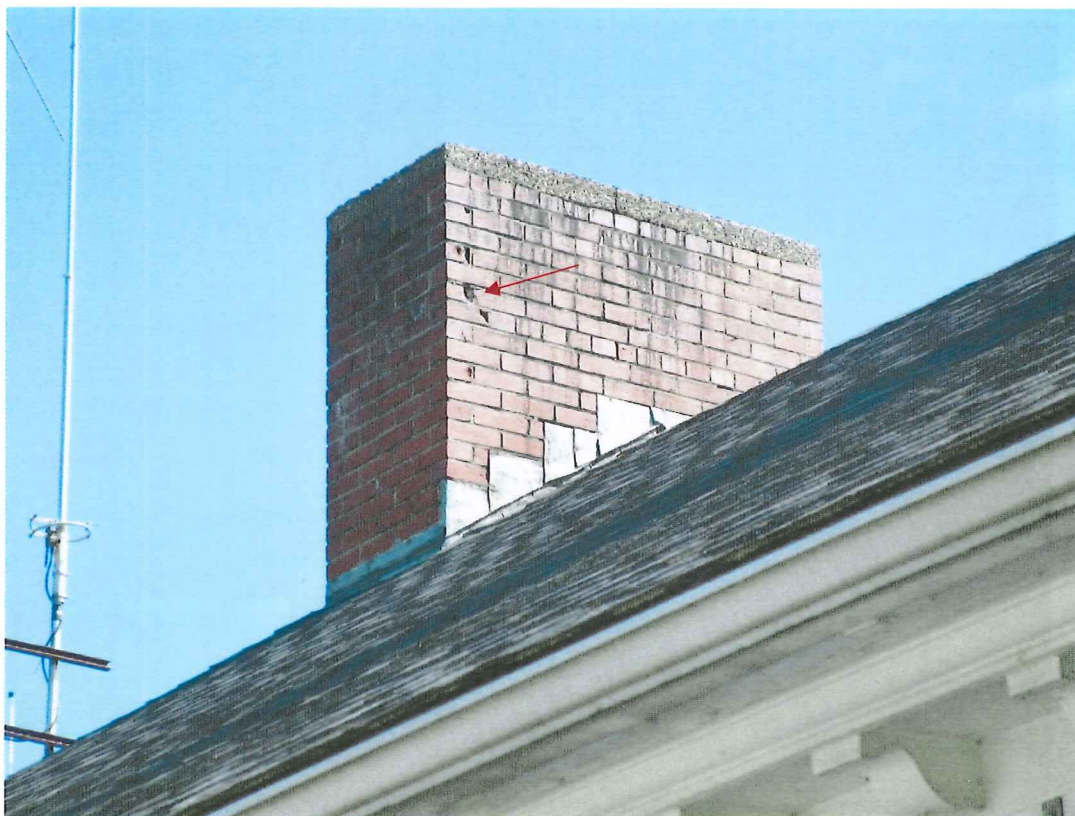
The brick chimney exhibited some spalling of the bricks and some deterioration of the mortar joints of the bricks (photos 29, 30).

29. Chimney, south and west sides. Spalled bricks.

7. Remove the caulk from the expansion joint and re-seal with elastomeric joint filler.
8. Re-point the chimney where needed and replace any spalled bricks.

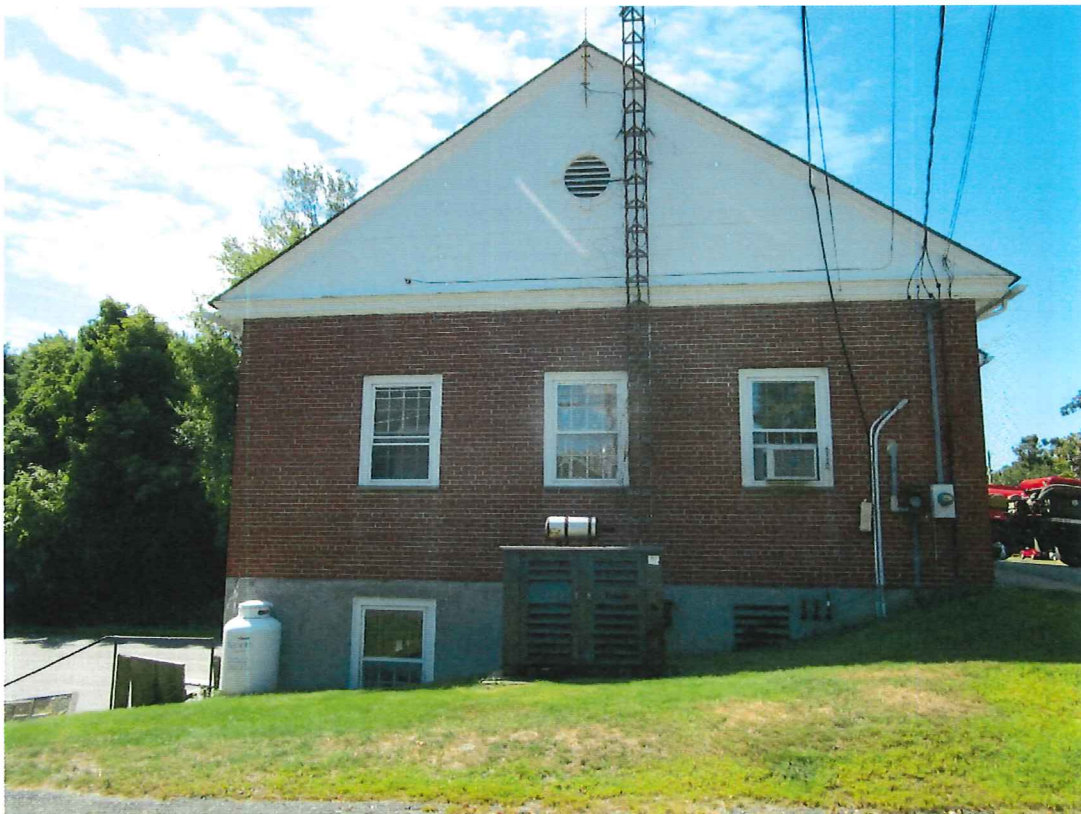
31. North side.

The north wall exhibited some cracking behind the antennae tower and at the edge of the window (photos 31 -34.) Also, there was some damage at the northeast corner that had been

9. Patch the cracks in the exterior concrete wall on the north side with Simpson Strong-Tie's ETI Injection Epoxy.
10. Patch the spalled concrete at the northeast corner of the foundation wall with SilproRepair™ VOH.

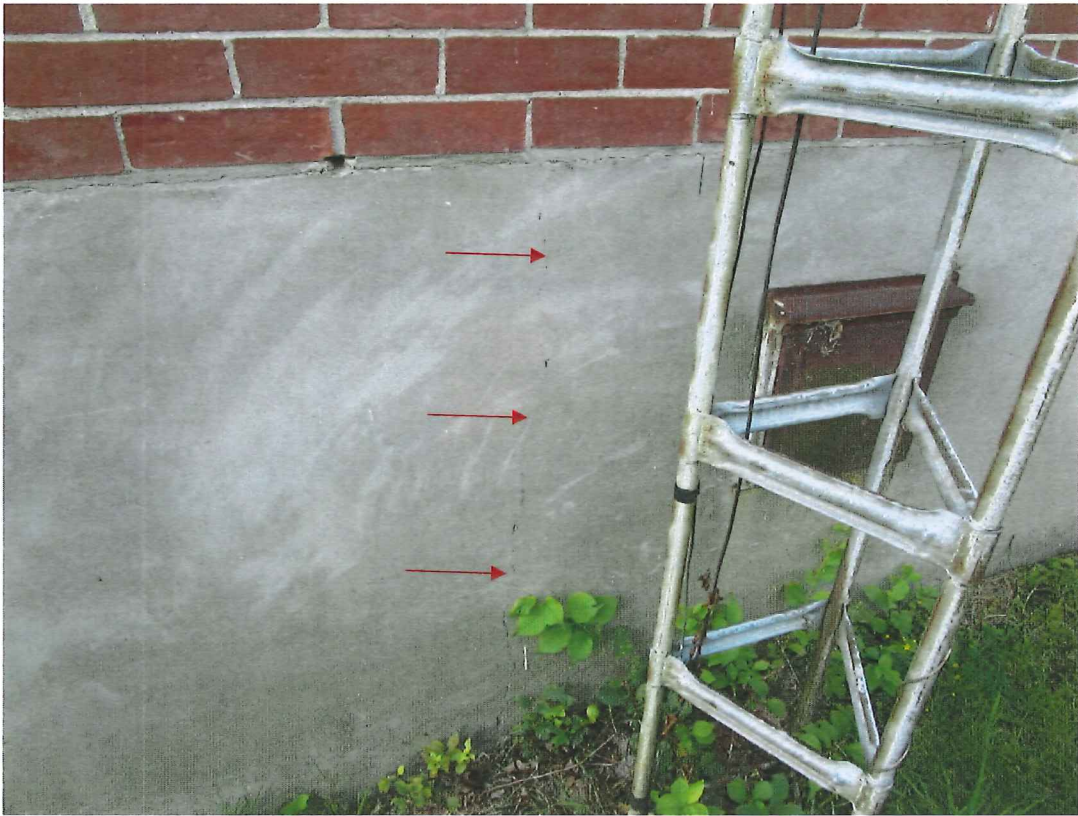
32. North side. Cracked foundation wall.

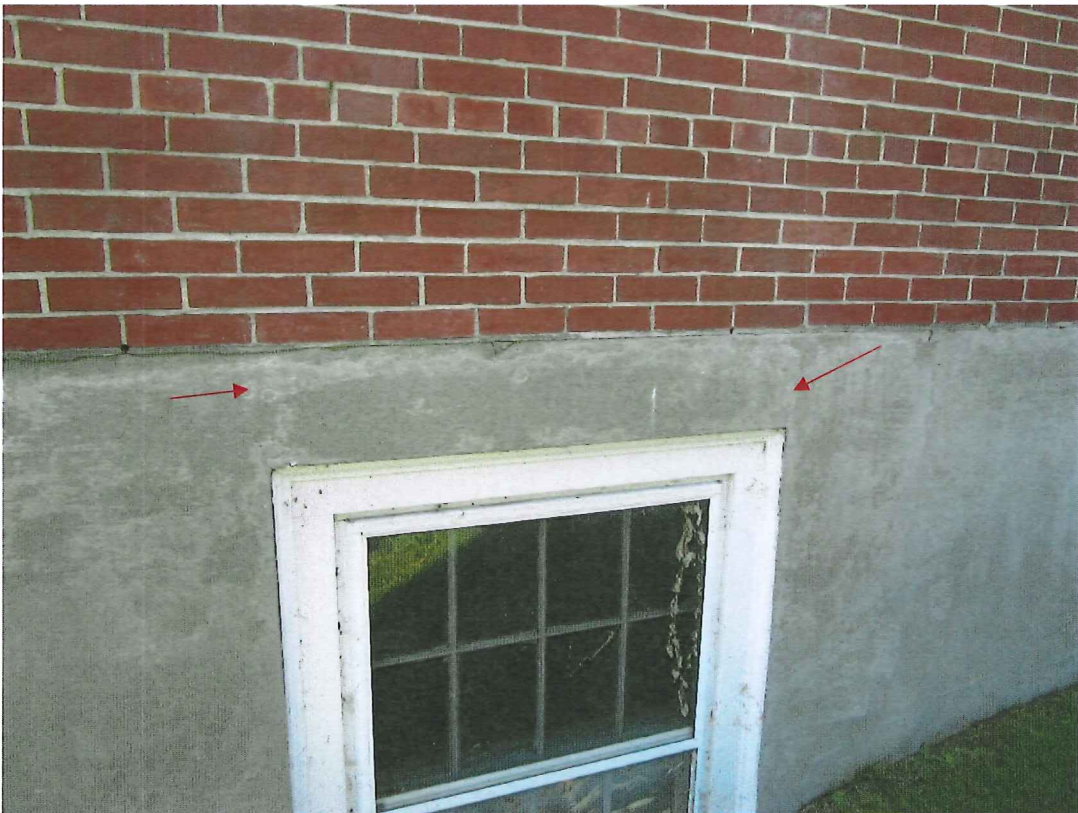
33. North side. Cracks at window edges.

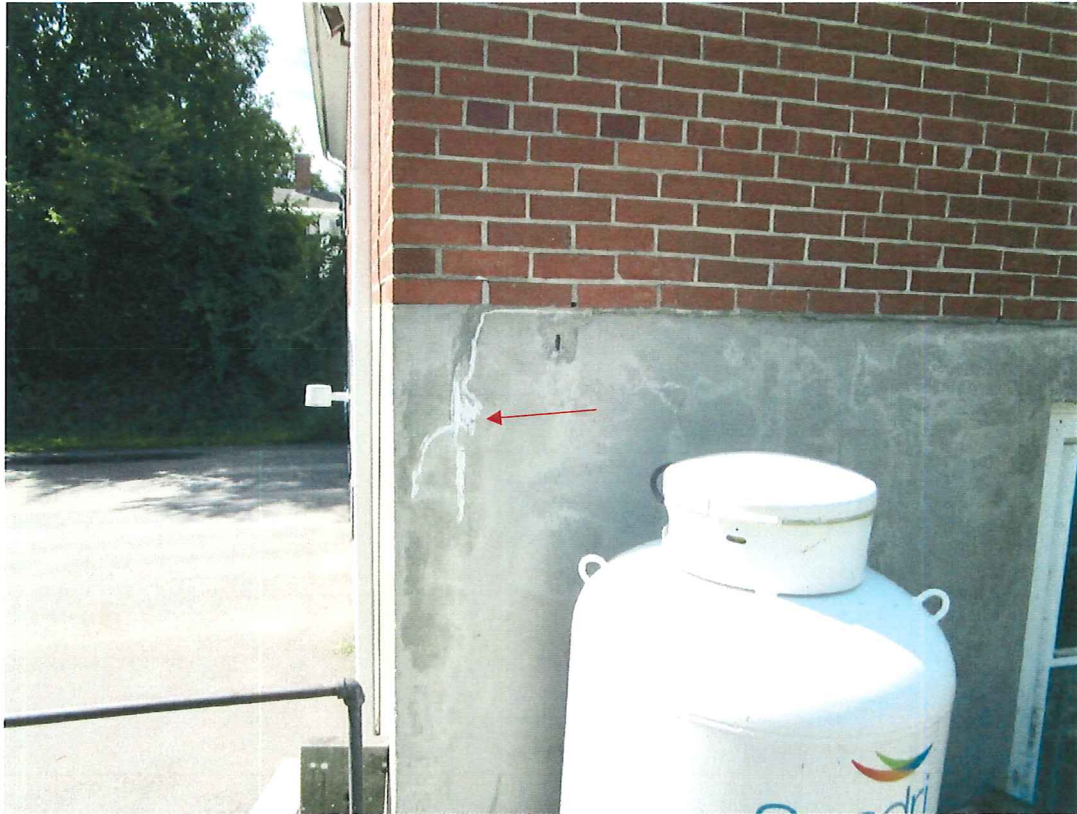
34. North side. Cracked concrete.

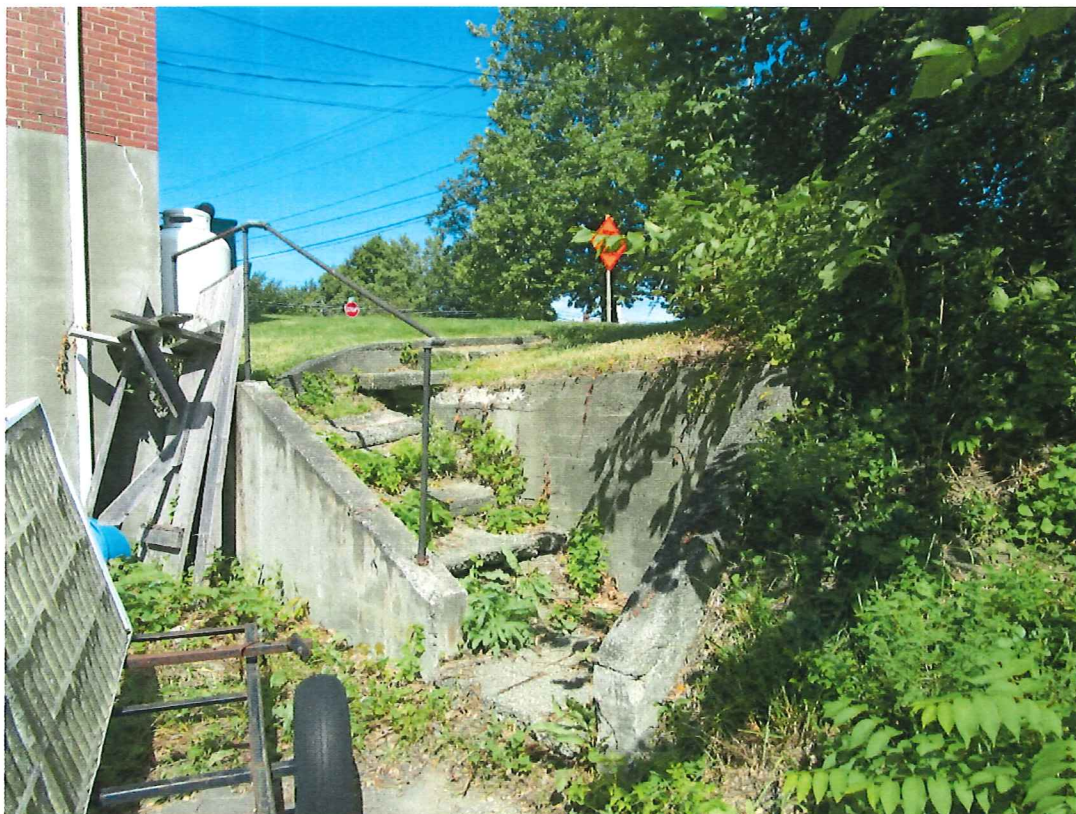
At the northeast corner, there is a broken-down set of concrete stairs (photo 35.) The stairs are in poor condition and are a safety hazard. They should be removed. If replaced, the new stairs need to meet the Building Code Requirements for commercial building stairs.

35. Northeast corner. Stairs are in unsafe condition.

11. Replace the exterior stair and retaining wall in the northeast corner.
