First Floor Slab Evaluation

Northfield Fire Station

93 Main Street

September 16, 2019

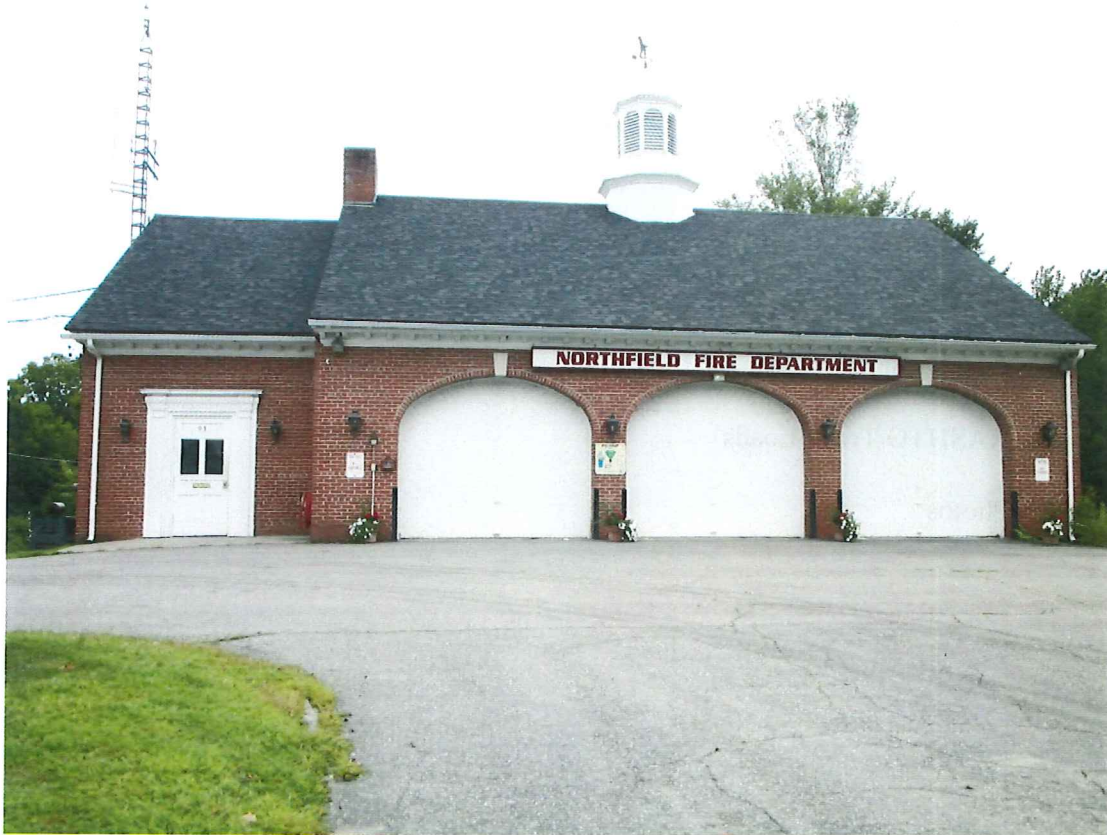
The fire station is a two story building constructed with concrete block and brick veneer walls built on a concrete foundation (cover photo.) The roof is wood framed.
